Llandeilo Common

A 50-YEAR PROJECT TO CREATE A NETWORK OF CLEAN WATER PONDS FOR FRESHWATER WILDLIFE

Background

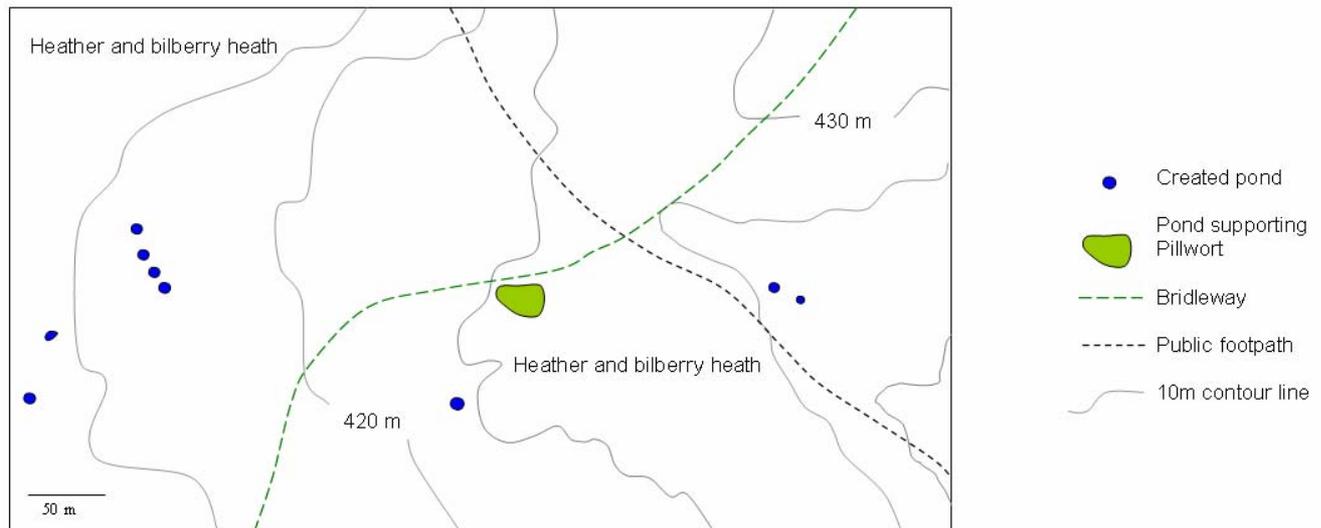
Figure 2. Sketch map of area

Sketch map showing the ponds created on Llandello Common

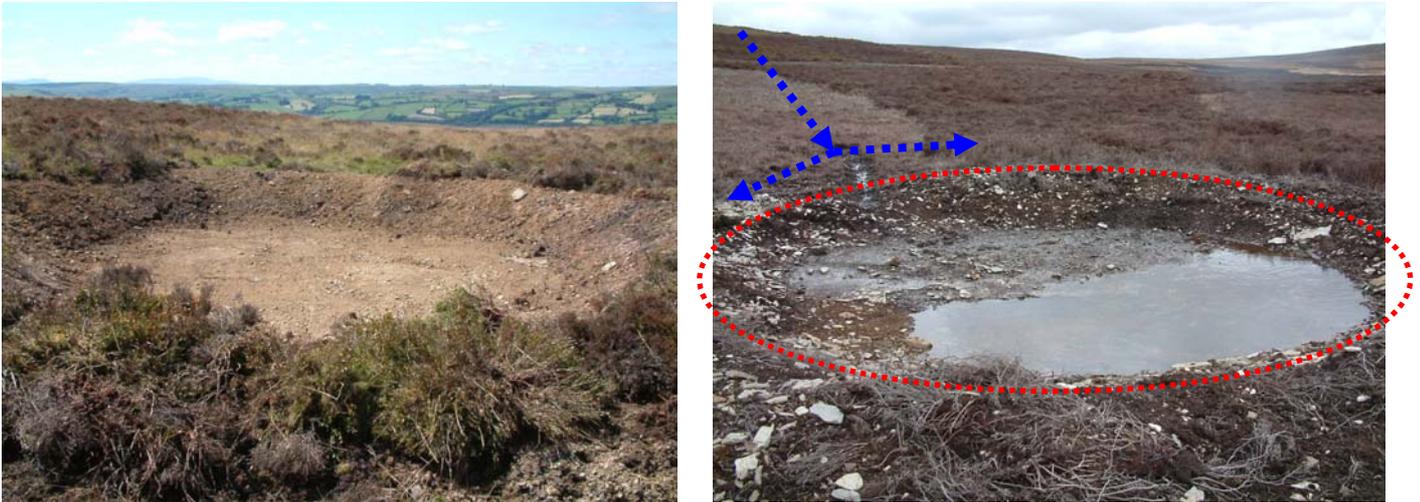
- The lack of supervision also means that the new ponds were poorly designed – more bomb crater than natural ponds:
 - The pond banks and sides were too steep – reducing the area of drawdown and so suitability for the target species.
 - Instead of the spoil being spread around the edges of the ponds it was landscaped into a ‘lip’ around the ponds which prevented surface run off entering the pond (see below).

Figure 3. Left: New pond showing the steepness of the pond banks. Right: Spoil was deposited around the edge of the newly created ponds forming a lip which prevented surface run-off from entering the pond. Path of surface run-off from *potential pond catchment area* is shown by the dotted blue line - and so considerably reducing the pond catchment area – *actual pond catchment area* shown here by the dotted red line. (Photographs: Pond Conservation)

- In most cases you need to dig and monitor trial holes to assess the water retaining capacity of the substrate. Test holes can be as small or as large as you need them to be, depending on the design of the ponds in the proposed scheme. They can be hand dug, or excavated using a digger, again depending on the scale of the scheme, the design specifications (do you want a permanent or temporary pond?), and the funding available.
- Make sure that all relevant parties are contacted and agree to the scheme before work takes place.
- Ensure that the contractor is properly briefed and supervised. Ideally plans should be drawn up – these can be rough or detailed, depending on the complexity of the scheme and the local conditions should ideally include surface area, maximum depth and bank angles.

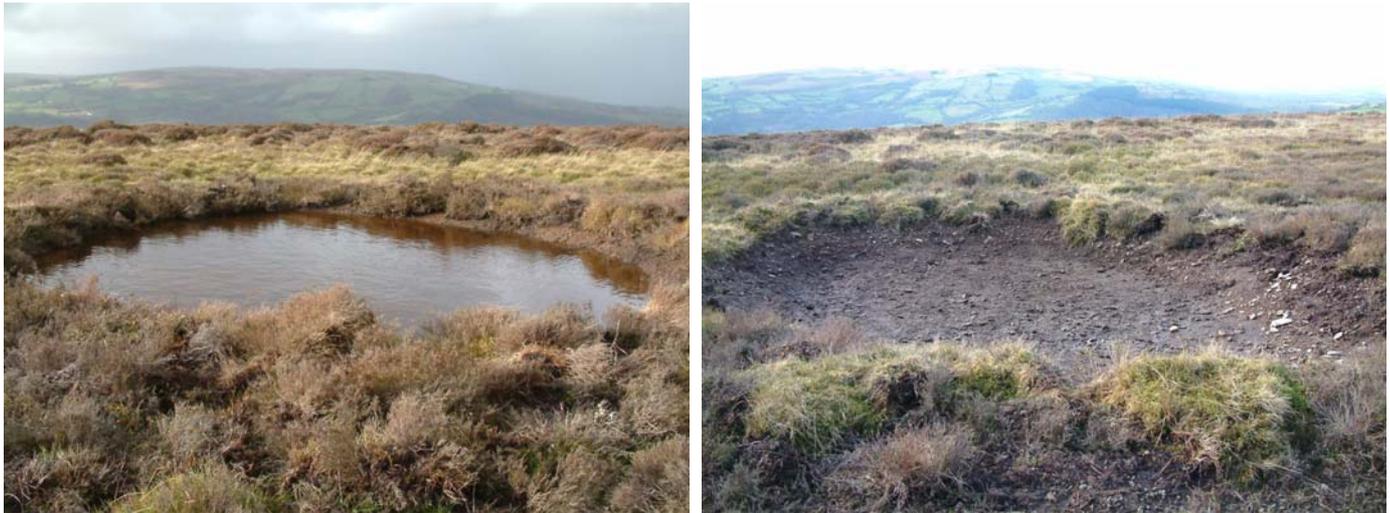
- Due to the nature of the substrate and the poor design which restricted the size of the pond catchment area, the ponds only held water for a short time after heavy rainfall – not long enough for wetland vegetation to become established.
- Since the ponds have failed to create wildlife habitat or additional watering points for livestock, and their design was so poor, all but two were filled in 2012.
- The two remaining ponds will be re-landscaped so that they can receive the run-off from the surrounding land and their banks will be made shallower so that a wider drawdown zone is created, and the pond design emulate existing ponds at the site. Over time they may self-seal as livestock compact the sediment and silt washes into them.
- The graziers are now working with the CCW officer to identify where new ponds may be located.

Figure 4. The new ponds created in 2009 would fill with water but then appear to be empty a short while later. These photos were taken 2 weeks apart. (Photographs: Pond Conservation).

- The total cost of excavating the ponds was £1725.00 for 9 ponds, which was covered by a grant from Biffaward through the Million Ponds Project's Pond Digging Fund.
- The estimated cost of filling eight of the ponds is about £300.
- Landscaping to improve the design of the remaining two ponds will be carried out by volunteers with the local Wildlife Trust.
